JP Home Inspection Report

5510 Sample St
Los Angeles, California

Prepared for: **Jau C Pu**

Prepared by: **JP Home Inspection**
15554 Gale Ave #114
Hacienda Heights, CA 91745
josephpupu@yahoo.com
909-720-0744

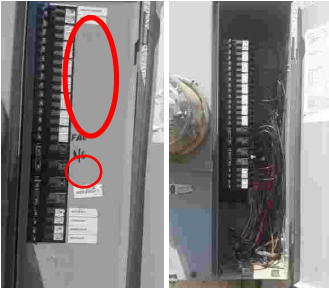
2. Back of house Electric Panel Main Breaker Size: 100 Amps - Recommend to label the electrical breakers.

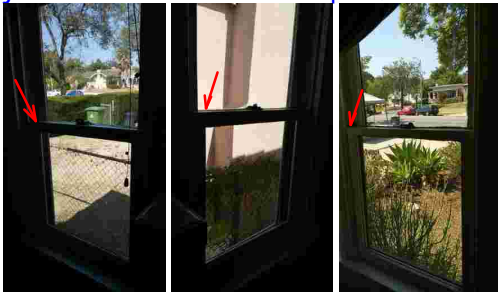
7. Living Room, Dining Room Living Space Windows: Single hung - Living room wood hung windows are paint jammed and cannot be open; review by a qualified person is recommended.

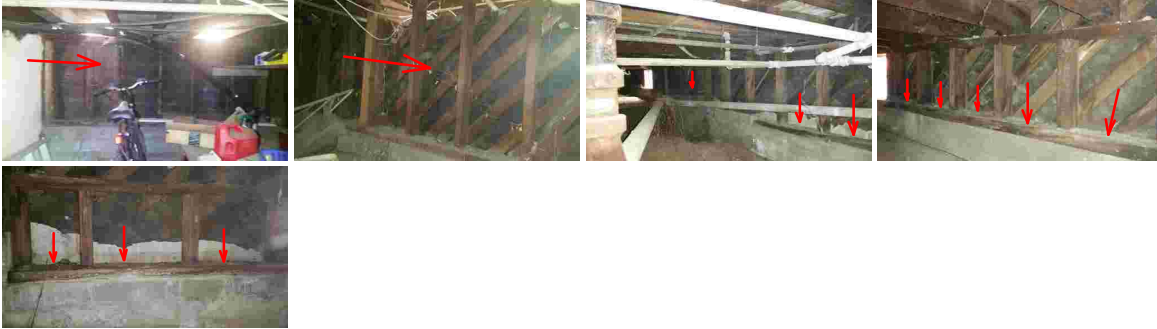
13. Foundation: Poured concrete - Plywood sheets for foundation cripple walls are missing and the sill plates are not bolted onto the concrete foundation wall; recommend to retrofit in the future and this is an optional upgrade.

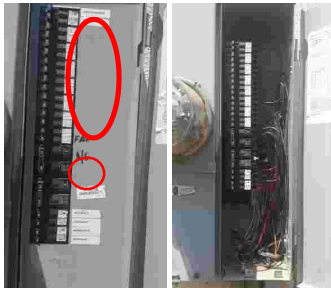
9. Manufacturer: Murray
10. Maximum Capacity: 100 Amps
11. Main Breaker Size: 100 Amps - [Recommend to label the electrical breakers.](#)

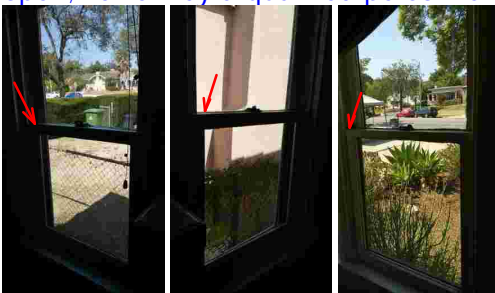
4. Floor: Hardwood
5. Doors:
6. Windows: Single hung - Living room wood hung windows are paint jammed and cannot be open; review by a qualified person is recommended.

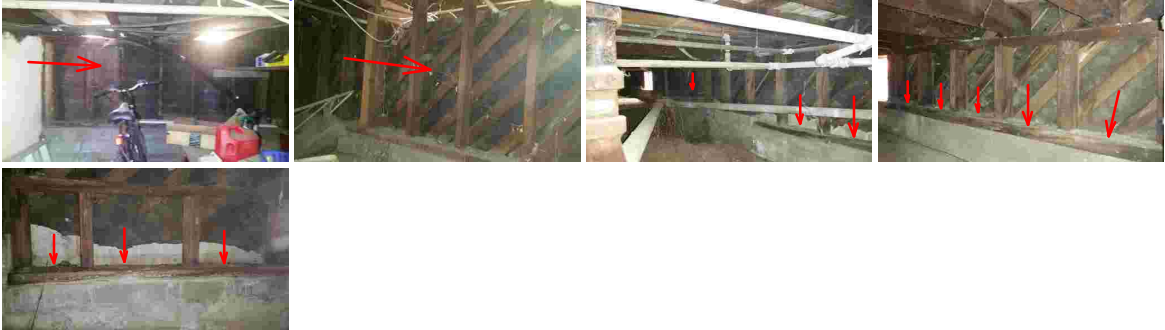
1. Structure Type: Wood frame
2. Foundation: Poured concrete - Plywood sheets for foundation cripple walls are missing and the sill plates are not bolted onto the concrete foundation wall; recommend to retrofit in the future and this is an optional upgrade.
