JP Home Inspection Report

13364 Sample St
Eastvale, California

Marginal Summary

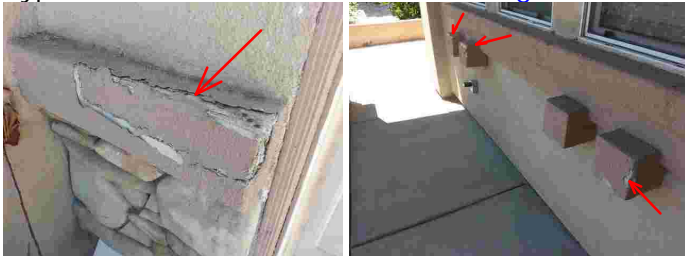
1. Type: Stucco - Exterior walls are damaged and deteriorated.

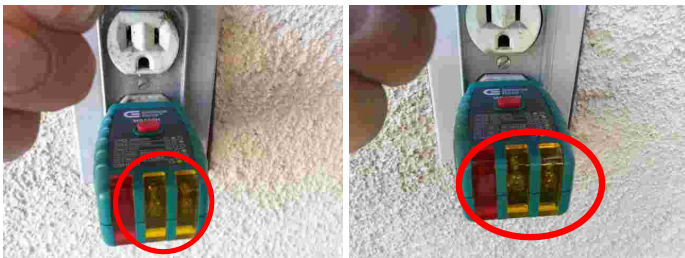
2. Exterior Electric Outlets: 110 VAC - Two exterior electric outlets are not working, inoperable; one at next to front door one at back of the house.

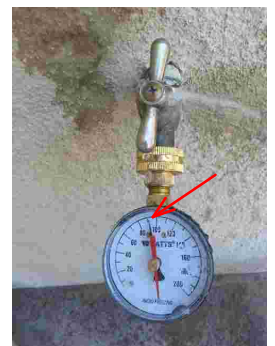
3. Hose Bibs: Ball - The water pressure of this house is about 90 psi. However, the maximum recommended pressure for a residence is 80 psi.

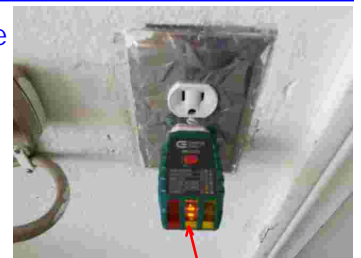
4. Front Garage Electrical: 110 VAC - The electrical outlet next to the Fire Rated Service door is open grounded; this is easy and cheap fix. Review by a qualified person is recommended.

When a grounding receptacle (three-holed type receptacle) does not actually have a grounding conductor(wire). This may mean a missing or unconnected grounding conductor(wire) at the receptacle, or one missing at an upstream receptacle.

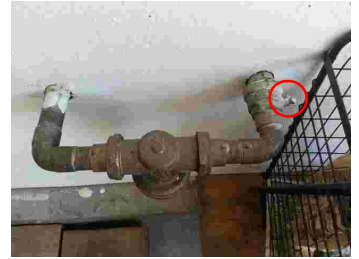
5. Main Water Shutoff: Garage - Main water shutoff valve handle is missing.

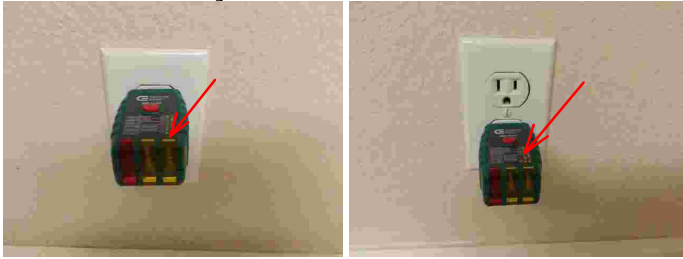
6. 1st Floor Laundry Room/Area Electrical: 110 VAC - Two electrical outlets are not working.

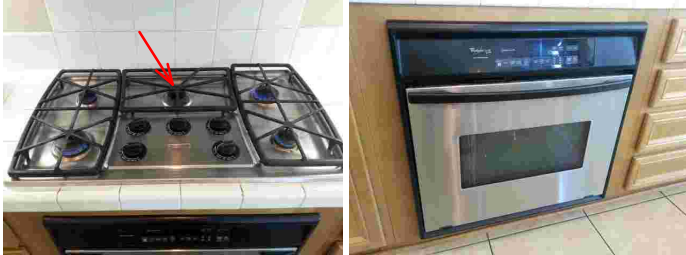
7. 1st Floor Kitchen Cooking Appliances: Whirlpool - One burner is not working.

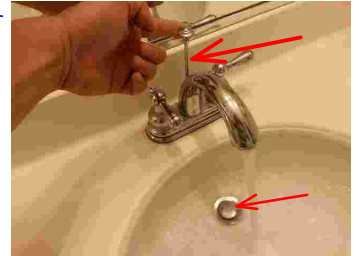
9. 2nd Floor Main Bathroom Sink/Basin: Porcelain - The left rod is loosed and the water stop is not working.

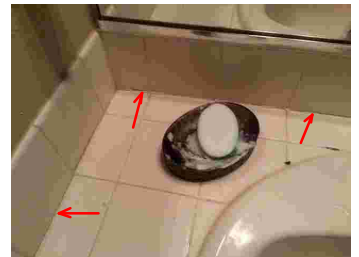
10. 1st Floor Main Bathroom Counter/Cabinet: Ceramic tile & Wood - Ceramic tile grout is dry cracked.

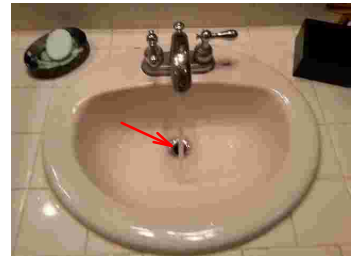
11. 1st Floor Main Bathroom Sink/Basin: Porcelain - Water stop is missing.

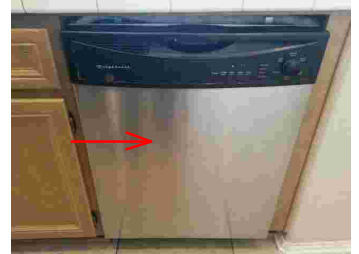
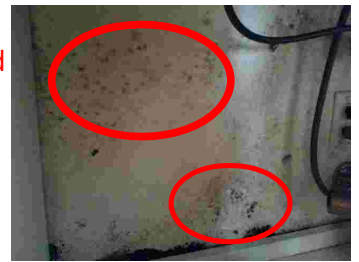
1. 1st Floor Kitchen Dishwasher: Frigidaire - **This dishwasher is not operable.**
2. 1st Floor Kitchen Cabinets: Wood - **The cabinet wall underneath the kitchen sink is rotten and unidentifiable bio organic material is observed; further review by a qualified person is recommended.**

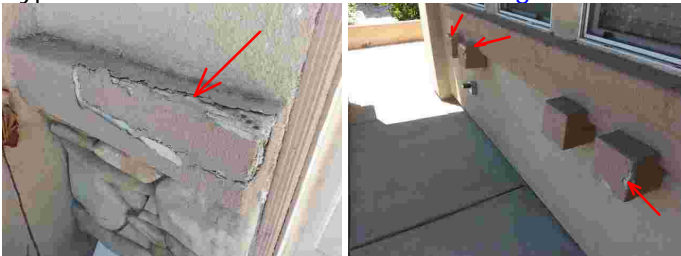
1. Type: Stucco - Exterior walls are damaged and deteriorated.

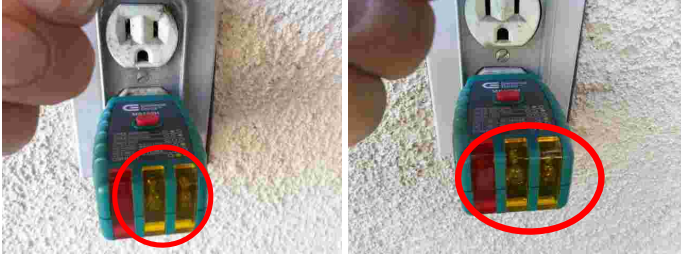
9. Window Screens: Vinyl mesh
10. Exterior Lighting: Surface mount
11. Exterior Electric Outlets: 110 VAC - Two exterior electric outlets are not working, inoperable; one at next to front door one at back of the house.

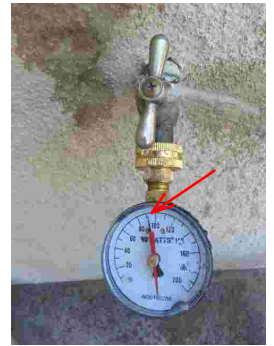
12. Hose Bibs: Ball - The water pressure of this house is about 90 psi. However, the maximum recommended pressure for a residence is 80 psi.

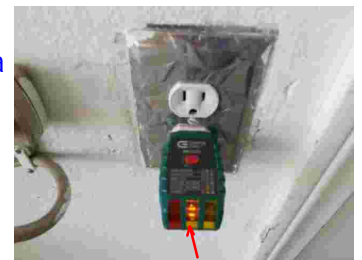
13. Electrical: 110 VAC - The electrical outlet next to the Fire Rated Service door is open grounded; this is easy and cheap fix. Review by a qualified person is recommended.

When a grounding receptacle (three-holed type receptacle) does not actually have a grounding conductor(wire). This may mean a missing or unconnected grounding conductor(wire) at the receptacle, or one missing at an upstream receptacle.

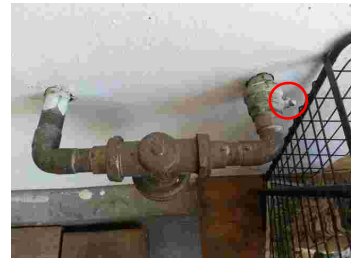
- Service Line: Copper
- Main Water Shutoff: Garage - [Main water shutoff valve handle is missing.](#)

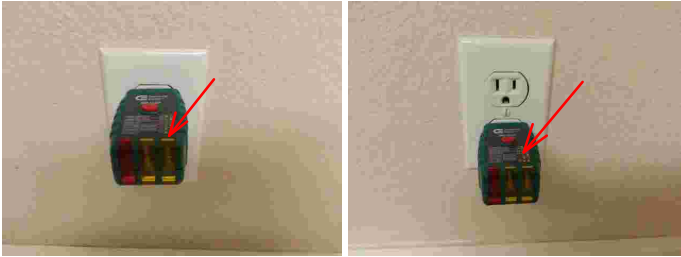
5. Doors: Hollow wood
6. Electrical: 110 VAC - Two electrical outlets are not working.

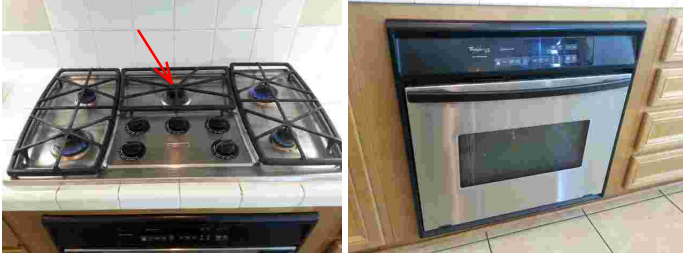
1. Cooking Appliances: Whirlpool - **One burner is not working.**

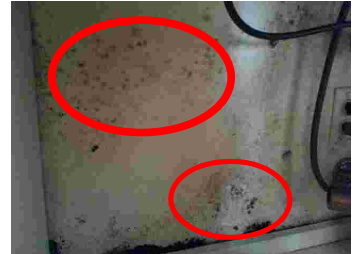
13. Cabinets: Wood - The cabinet wall underneath the kitchen sink is rotten and unidentifiable bio organic material is observed; further review by a qualified person is recommended.

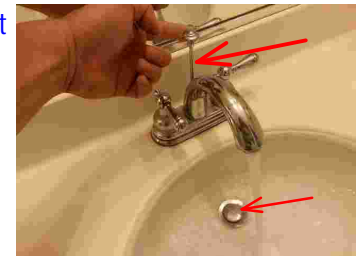
22. Sink/Basin: Porcelain - The left rod is loosed and the water stop is not working.

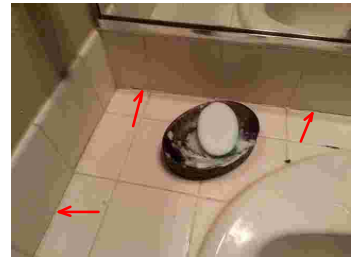
29. Closet:
30. Ceiling: Paint
31. Walls: Paint
32. Floor: Ceramic tile
33. Doors: Hollow wood
34. Windows:
35. Electrical: 110 VAC
36. Counter/Cabinet: Ceramic tile & Wood - Ceramic tile grout is dry cracked.

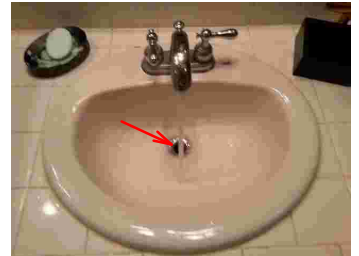
37. Sink/Basin: Porcelain - Water stop is missing.
