JP Home Inspection Report

5510 Sample St
Los Angeles, California

Prepared for: **Jau C Pu**

Prepared by: **JP Home Inspection**
15554 Gale Ave #114
Hacienda Heights, CA 91745
josephpupu@yahoo.com
909-720-0744

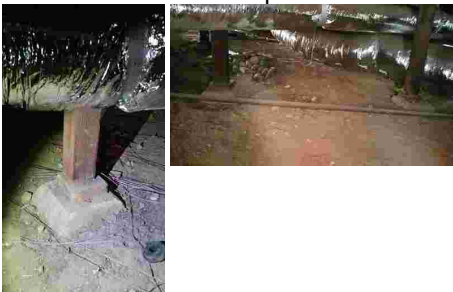
3. Differential Movement: No movement or displacement noted
4. Bearing Walls: Not visible
5. Joists/Trusses: Not visible
6. Piers/Posts: Poured piers and wood posts
