JP Home Inspection Report

13364 Sample St
Eastvale, California

Marginal Summary

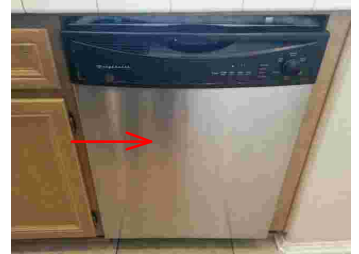
1. 1st Floor Kitchen Dishwasher: Frigidaire - **This dishwasher is not operable.**
2. 1st Floor Kitchen Cabinets: Wood - **The cabinet wall underneath the kitchen sink is rotten and unidentifiable bio organic material is observed; further review by a qualified person is recommended.**

4. Dishwasher: Frigidaire - This dishwasher is not operable.
